Re: September 2014 Monthly Progress Report  
Administrative Settlement Agreement and Order on Consent for Removal Action  
U.S. EPA Region 10 Docket No. CERCLA 10-2009-0255  
Gasco Sediments Site within the Portland Harbor Superfund Site

Attachment A      Monthly Visual Monitoring Report for Pilot Cap Vicinity

## Visual Observations Log Form

**Monitoring Period:** Monthly (Year 8)—September 2014

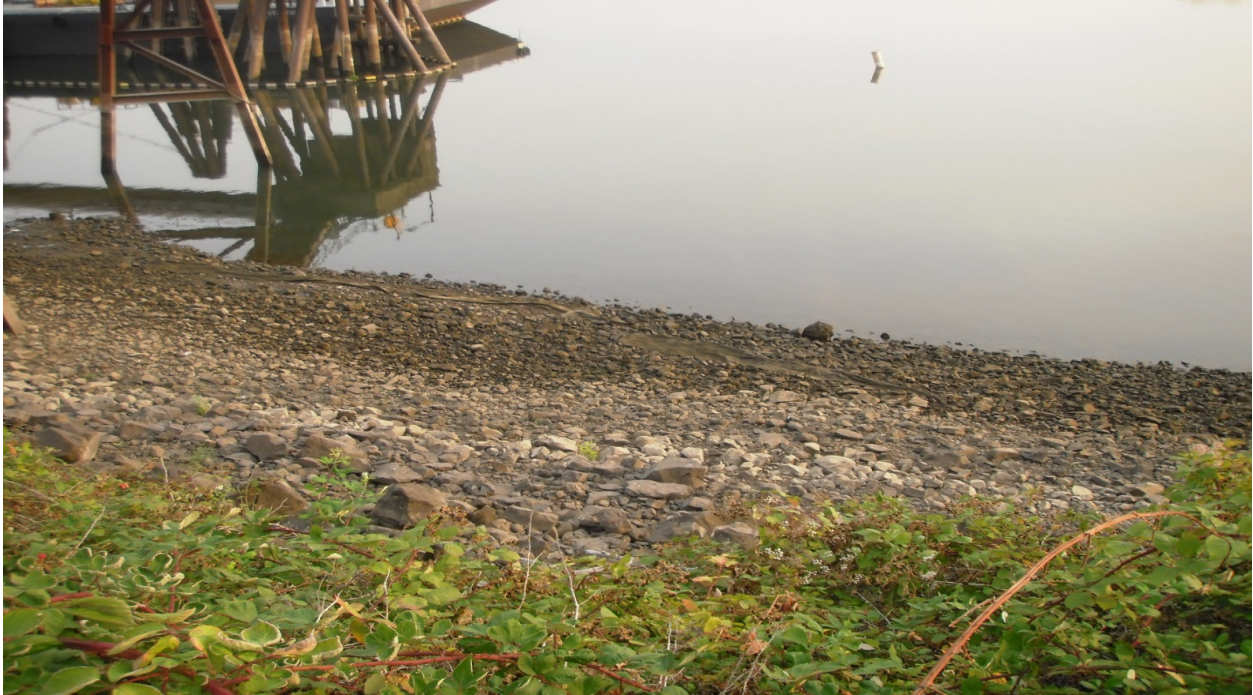
**Observations of Erosion/Deposition:** Four organo-clay mat material segments are visible and totally out of the water. A segment measuring 5-foot in length is within 5 -6 feet of the water's edge near the lateral mid-point of the cap area. A 20 foot section is shoreward of the water's edge located perpendicular to the shoreline at the upriver boundary of the cap. A section of organoclay mat material measuring 40 feet in length is exposed near the downriver extent of the cap at the water's edge (Photo 1). Two areas of exposed organoclay mat material measuring 1-2 feet in length were visible for the first time as a result of an extremely low river level at the time of this observation.

Photo 1 — *Visible section of organo-clay mat at the downriver extent of cap area (9/16/14):*

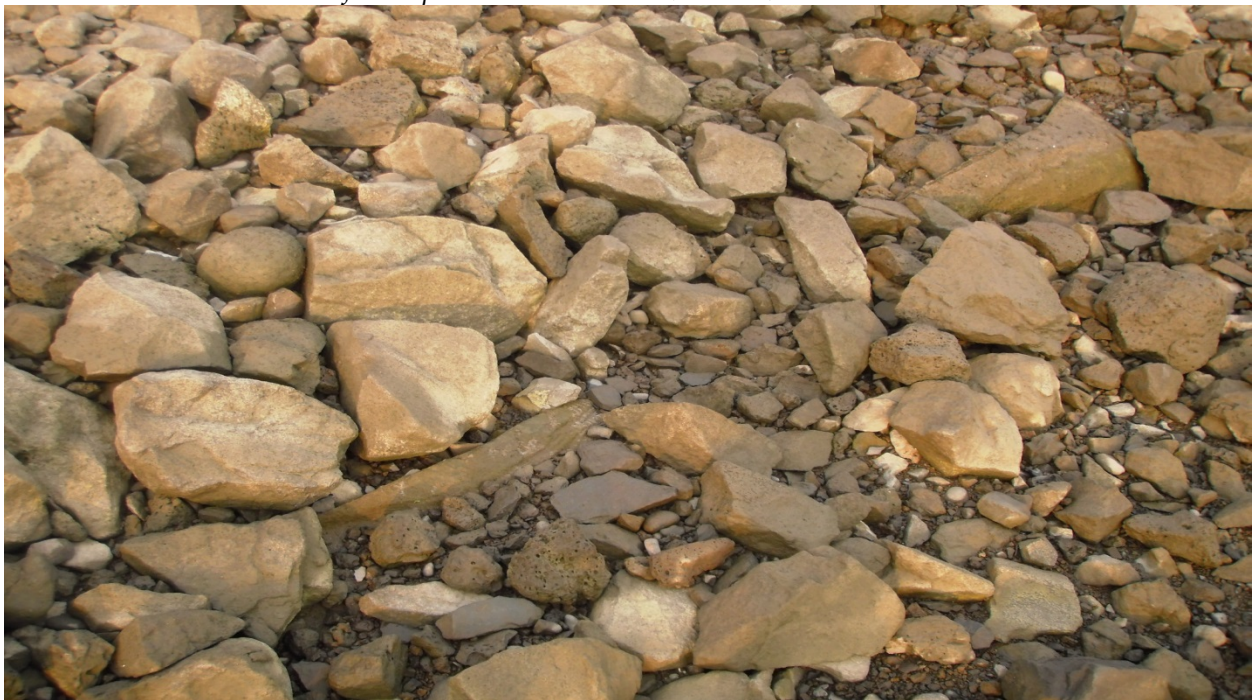
Photo 2 – *New one and two foot exposed sections noted (9/16/14):*

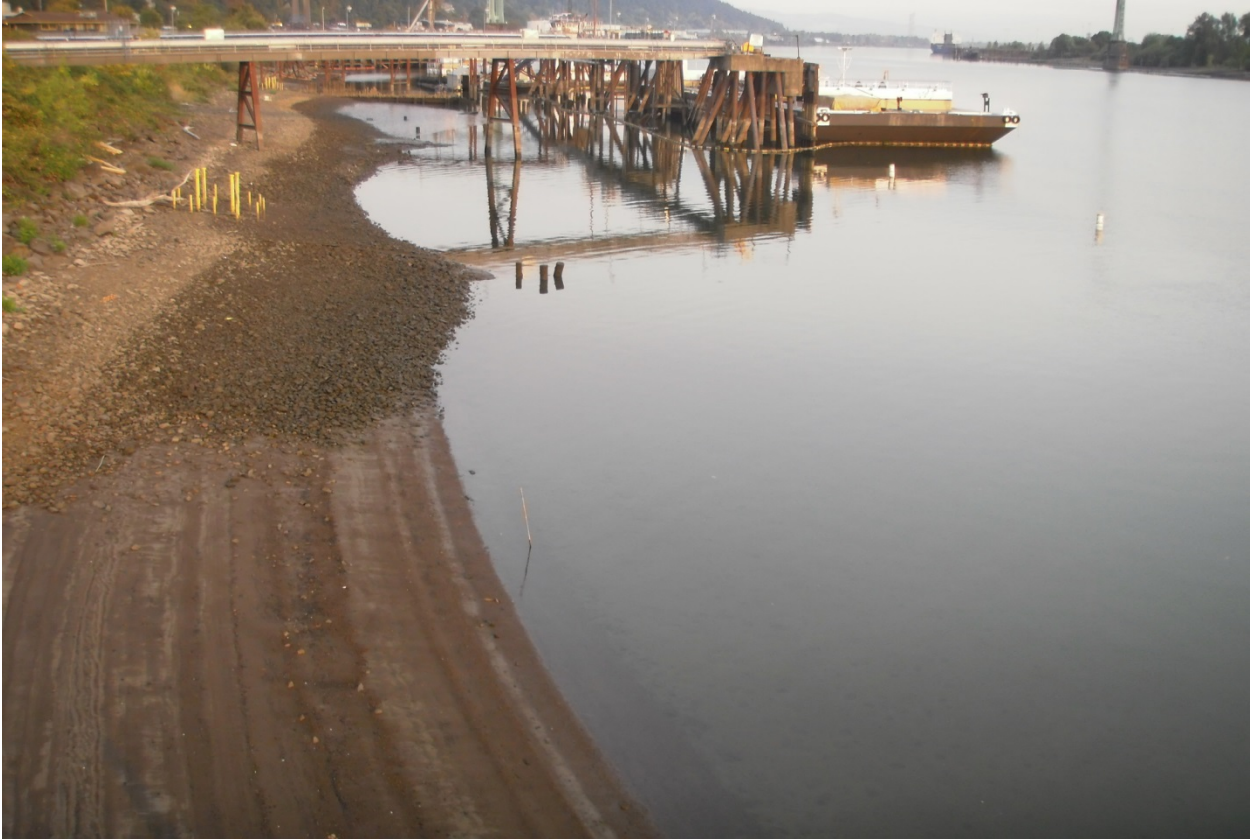
**Observations of Long-term Controls (i.e., oil booms, organo-clay mat, etc.)** During the observation, a barge was tied at the pier and the Fuel and Marine Marketing (FAMM) containment boom was placed around a barge at the ship dock during refueling operations. Two buoys that identify the cap area to mariners are in place as installed. The position of the FAMM oil boom, warning buoys, and a general overview of the site shoreline is shown in Photo 3.

Photo 3 — *FAMM oil boom placement and mariner warning buoys at pilot cap area. (9/16/14):*

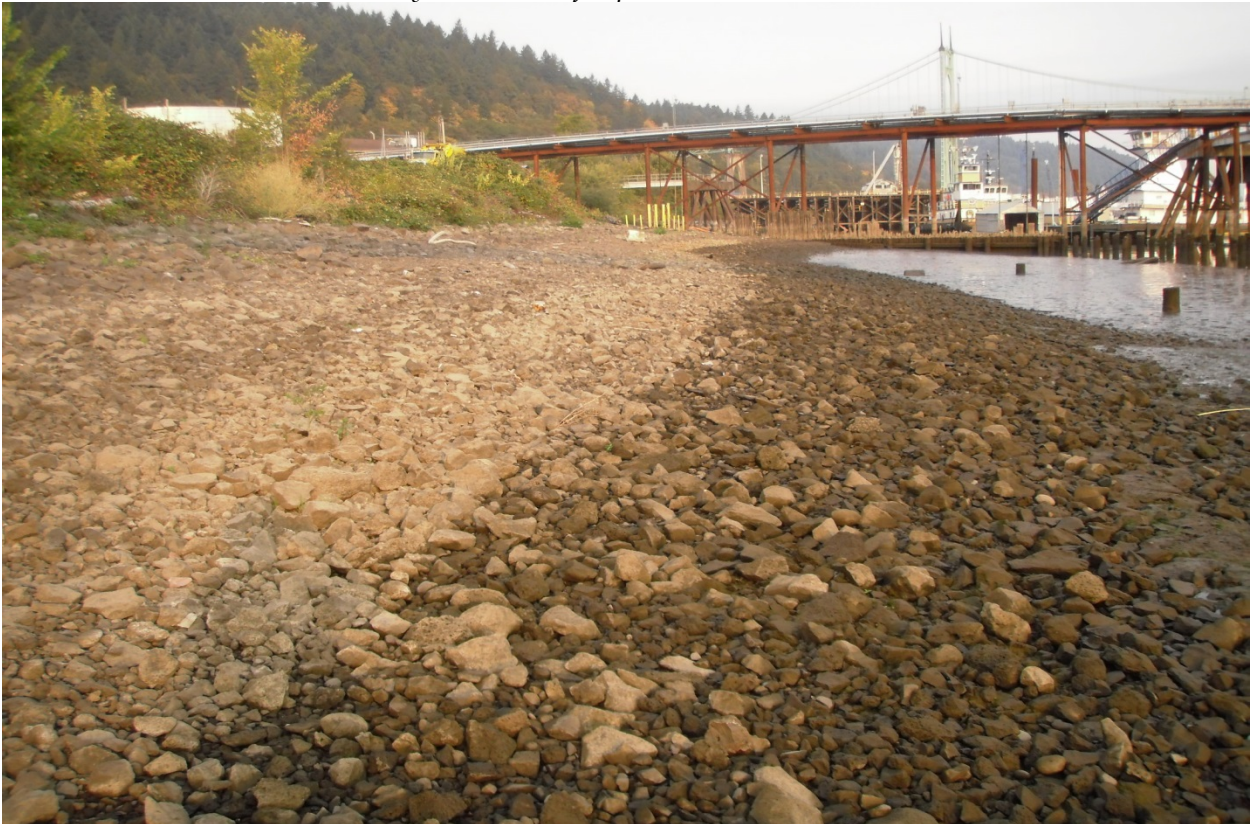
No sheen is evident in or around the cap area. Photo 4 shows the water surface and shoreline immediately downriver of the sediment cap.

Photo 4 — *Conditions immediately downriver of cap area (9/16/14):*
